# AVN NAVSAFECEN MISHAP CODE SHEET

1. AIRCRAFT ACCIDENT BOARD APPOINTED BY OINC, VR-24 DET	2. SERIAL NO 1-69A	3. DTG (LOCAL) OF MISHAP 220103 MAR 69	4. MODEL AIRCRAFT C-7A	5. BUREAU NUMBER 746019
6. TO: Commander, Naval Aviation Safety Center	7. VIA: CO, VR-24	8. 11. TIME OF DAY Night	12. TIME IN FLIGHT 4.4	10. DAMAGE Substantial
9. LOCATION OF MISHAP NAF, Naples	13. FLIGHT CODE 3A4	14. CLEARED FROM CVA-38 TO: Naples	15. TYPE CLEARANCE I	16. AIRSPEED 160
17. A/C WEIGHT 18 050 24.4 <sup>2</sup> nac	18. ELEVATION AT TIME OF MISHAP S.L. 280 TERRAIN 0	19. BRIEF DESCRIPTION OF MISHAP Nose wheel up landing		
20. LIST MODEL, BUFG, REPORTING CUSTODIAN AND DAMAGE CLASSIFICATION OF ANY OTHER A/C INVOLVED (Complete OPNAV Form 3750-1 for each A/C) None

DAMAGE TO AIRCRAFT

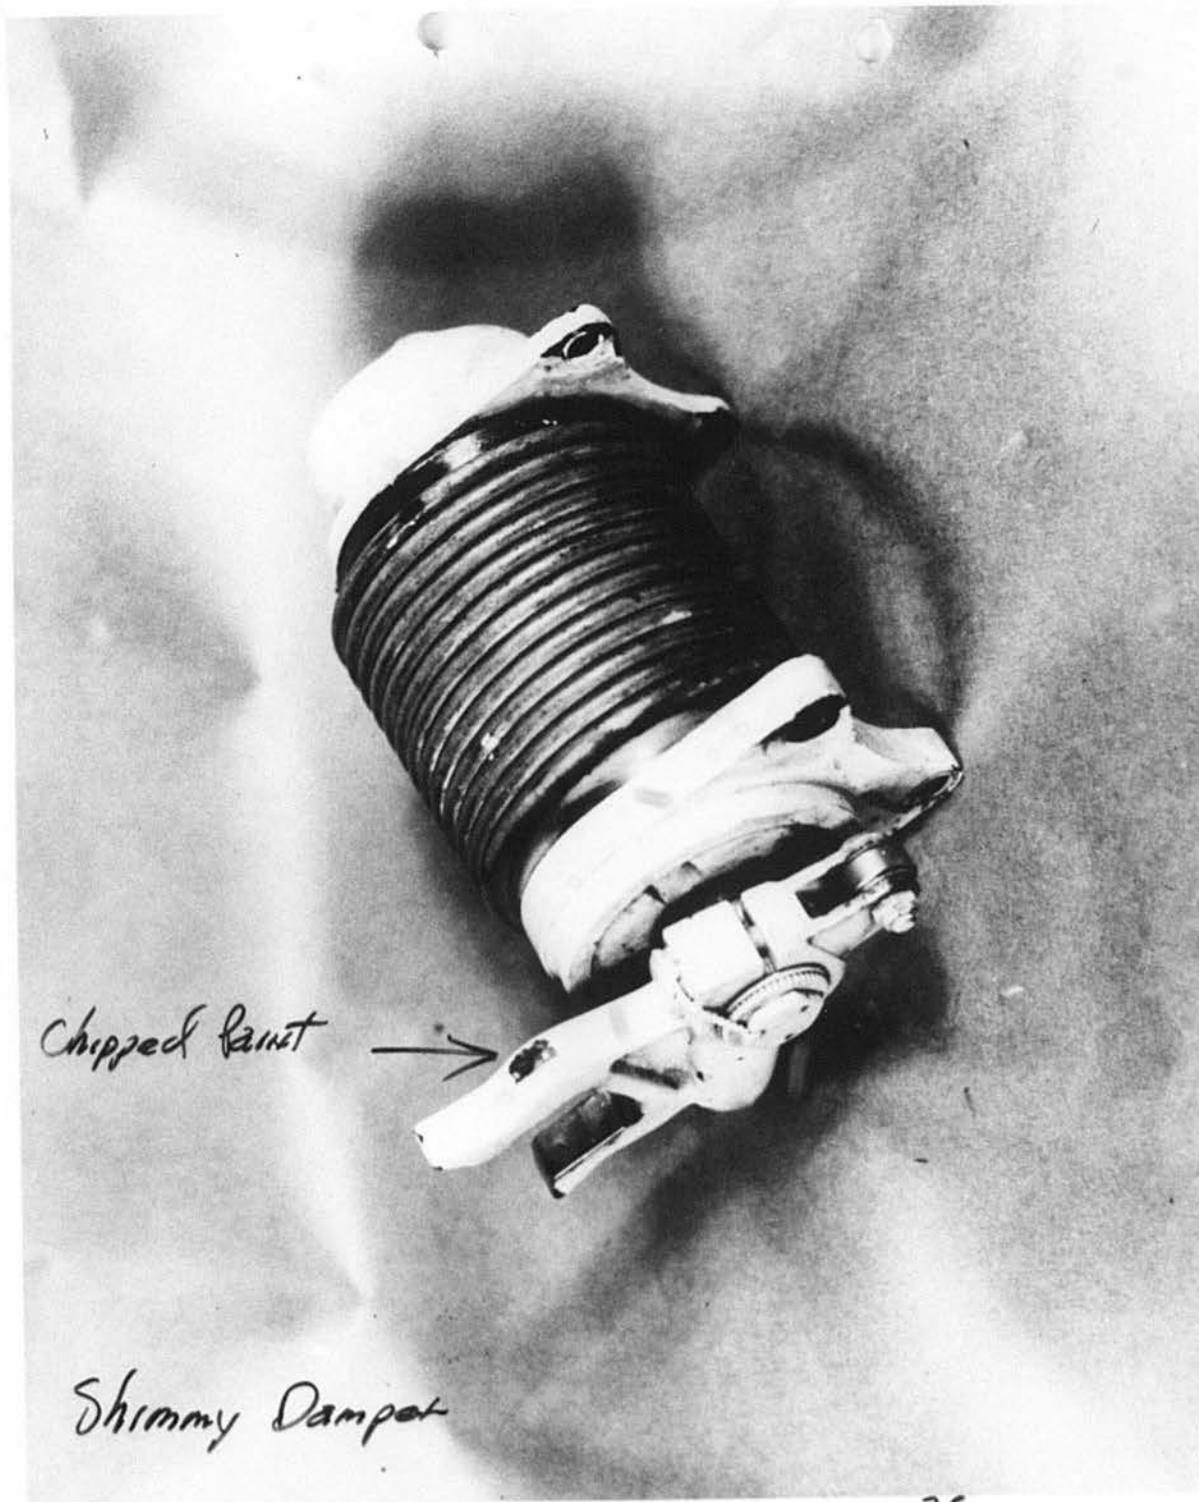
ENCLOSURE 3F

1. All damage to the aircraft was sustained when the nose of the aircraft contacted the runway. The damages were confined to the nose wheel well and the lower forward fuselage in the area of the nose gear between FS 56.0 and FS 120.0.

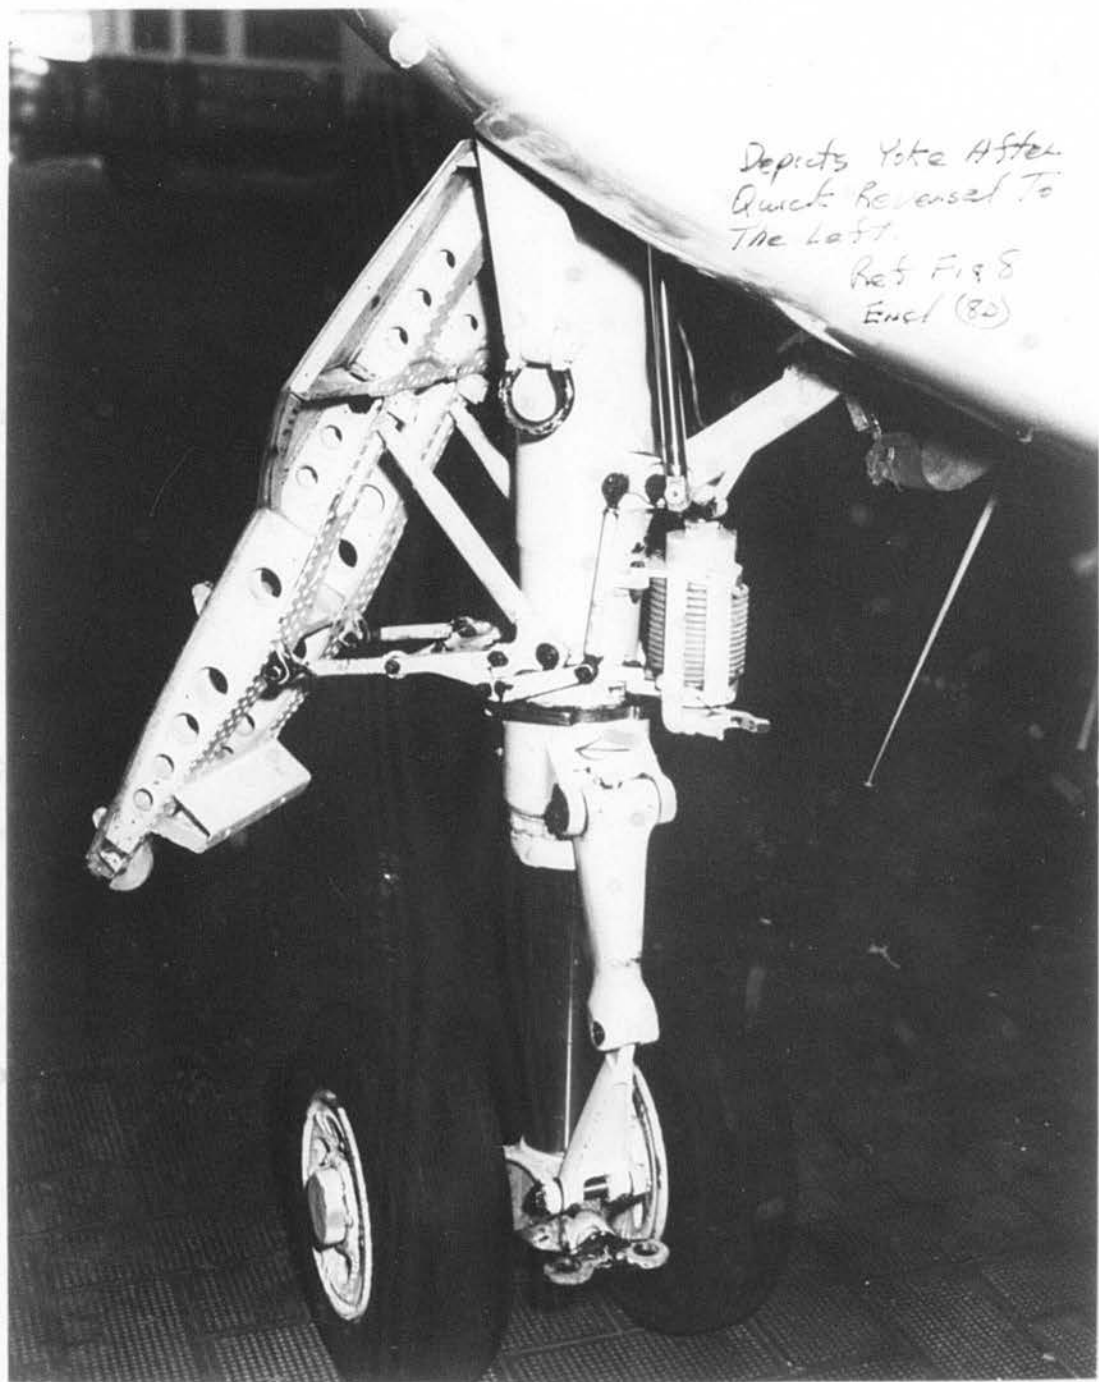
Ref Fig 8  
Encl (80)

1. The factors contributing to a nose gear up landing were:
  - a. The aircraft was catapulted with the shimmy damper roller probably out and adjacent to the shimmy damper yoke.
  - b. The pilots erred in not adhering to the CLL NATOPS procedures when a landing gear malfunction exists. After receiving an unsafe nose gear indication, the pilot lowered the gear to a down and locked indication then recycled the gear to a hung position.
  - c. The Plane Commander, acting as copilot, erred in the proper supervision of the pilots activities. He also erred in the procedures for troubleshooting a hung nose gear in that he attempted to bleed the normal system hydraulic pressure by actuating the emergency flap system, although the proper procedures would probably have not aided in dislodging the nose gear.

Depicts Yoke After  
Quick Reversal To  
The Left.

4. The Board recommends that luminous paint marking be applied to sides of the fixed and swivel portions of the nose gear so as to reflect proper alignment.

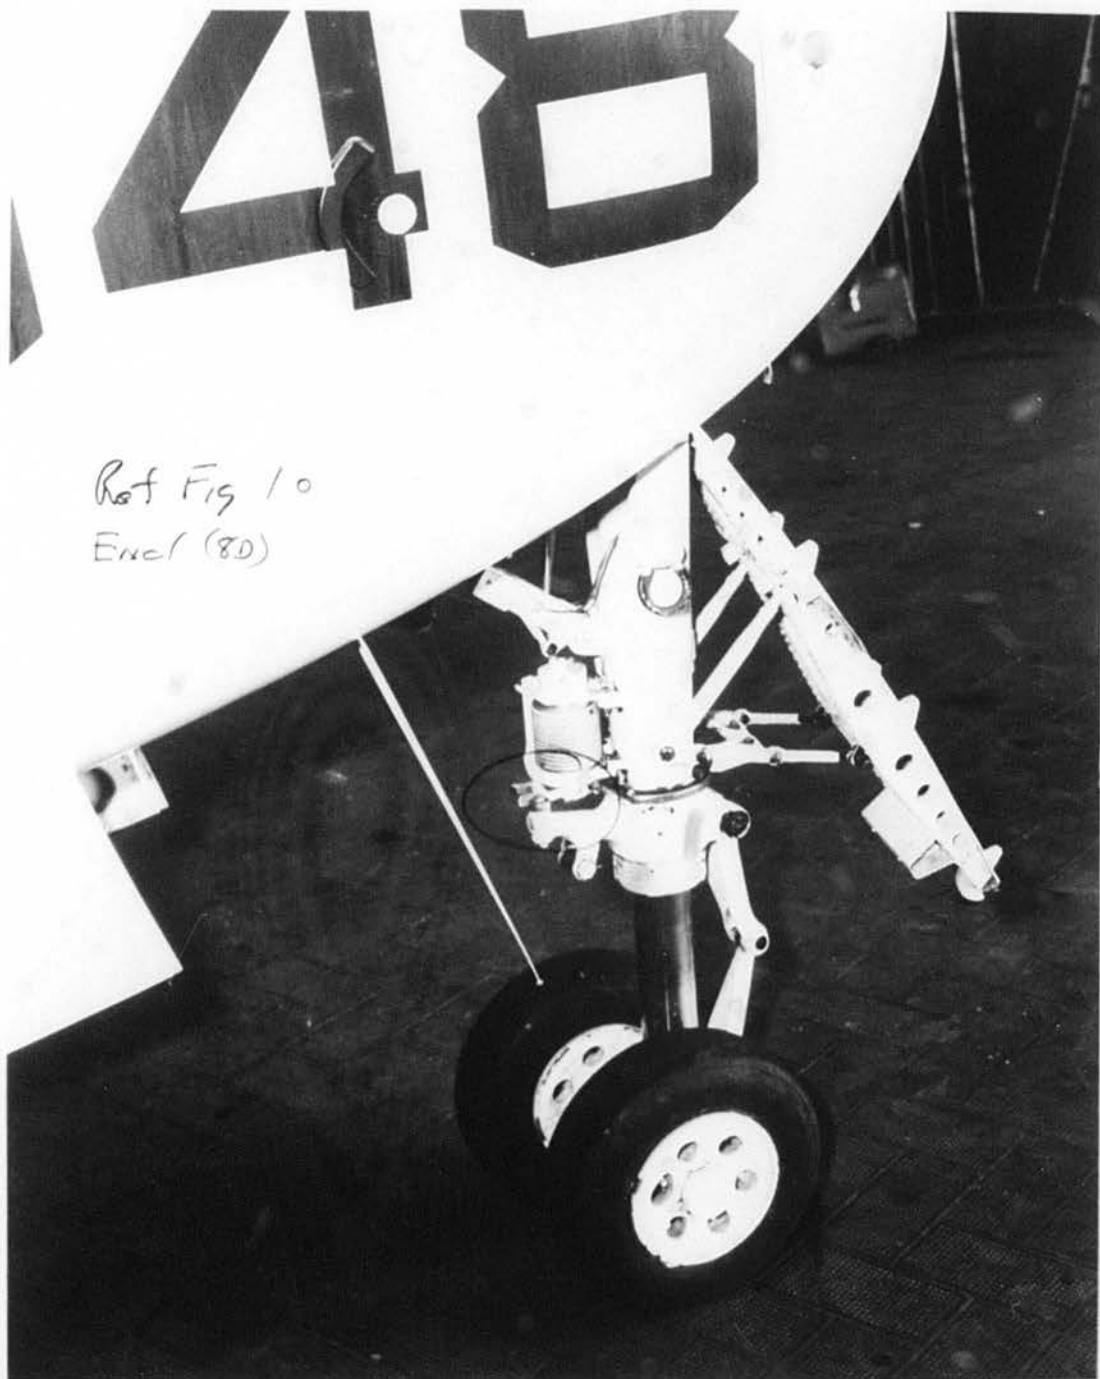
NORMAL SEQUENCE FOR SHIMMY DAMPER ROLLER AND YOKE

c. After an arrested landing, the roll back, braking and taxiing out of the arresting gear may cause the nose gear to oscillate in a manner so as to position the shimmy damper yoke out of sequence for recieving the shimmy damper roller. The roller will be outside and adjacent to the aligned yoke but during taxiing, heavy nose forces will allow the roller to force the yoke to onside thereby positioning the nose wheels fore and aft. When the nose forces decrease, the preload pressure of the shimmy damper will return the yoke to aft center forcing the roller and wheels to a side angle. At this angle one of the nose wheels will contact a nose well door when being raised. A keen flight deck observer is required to detect this discrepancy.

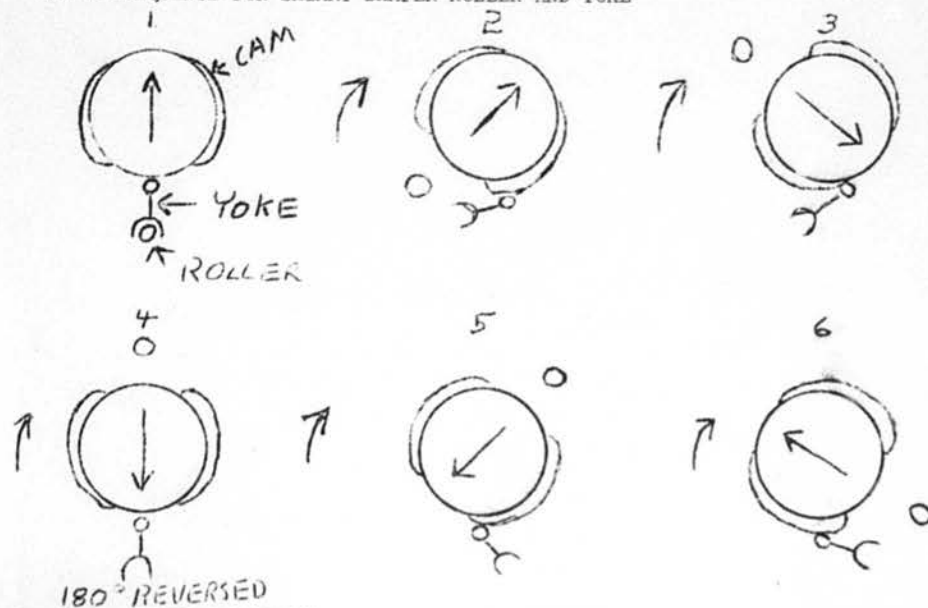
180° REVERSED

THE SEQUENCE WHICH RESULTS IN THE ROLLER AND YOKE BEING MISALIGNED
